Mercury Marine Product Development and Engineering

Marine Outboard Catalyst Research Project

**Final Report: Large Outboard Catalyst Endurance
and Small Outboard Catalyst Design and
Development**

CARB Contract 10-629

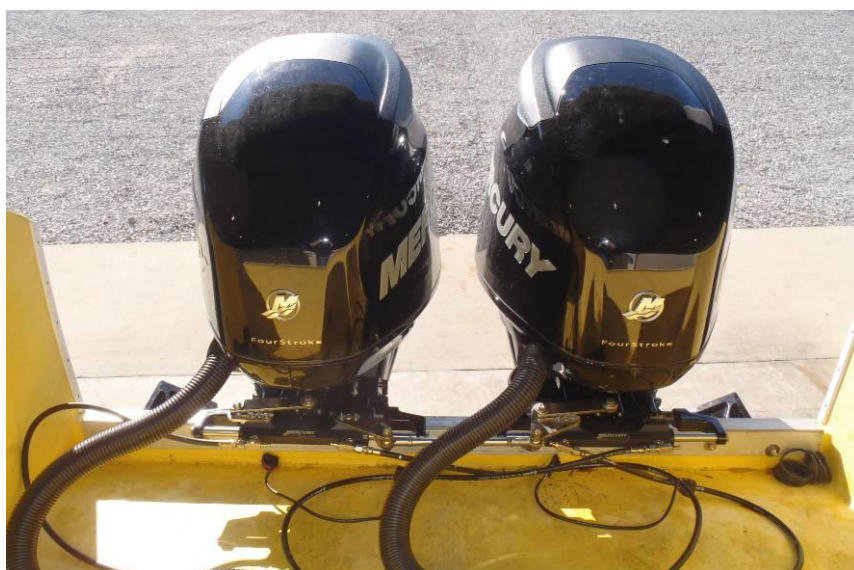
Figure 1: Large Outboard Boat Endurance Installation – Front/Top View

The first half of the endurance test was then performed. The engines were shipped to Mercury’s saltwater boat endurance test facility. The engines were rigged as a dual application on a 30’ vessel, as shown in Figures 1 and 2 below. Each engine was fitted with the appropriate propeller to operate the engine approximately in the midpoint of the rated speed range at wide open throttle. The fuel used for endurance testing was gasoline with 10% ethanol (E10). The engine instrumentation was continuously monitored and data were recorded for the duration of the endurance test. Periodic scheduled maintenance was performed on each engine per the Owner’s Manual appropriate for the non-catalyst equivalent engine. This maintenance was performed in typical customer maintenance intervals since the boat endurance test procedure was intended to simulate typical customer use. The engines were operated at approximate speed points for given durations to simulate the ICOMIA test cycle². Testing included shifting, shutdown, and startup maneuvers to simulate real world usage. Testing on the boat in the saltwater environment provided a variety of environmental conditions and various sea conditions.

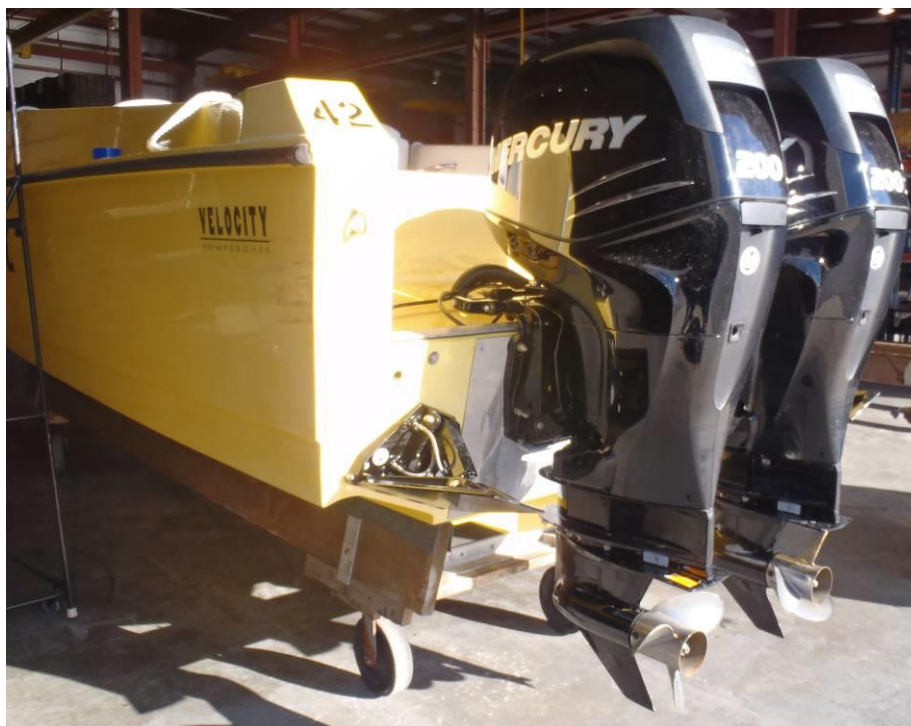
Figure 2: Large Outboard Boat Endurance Installation – Side/Back View

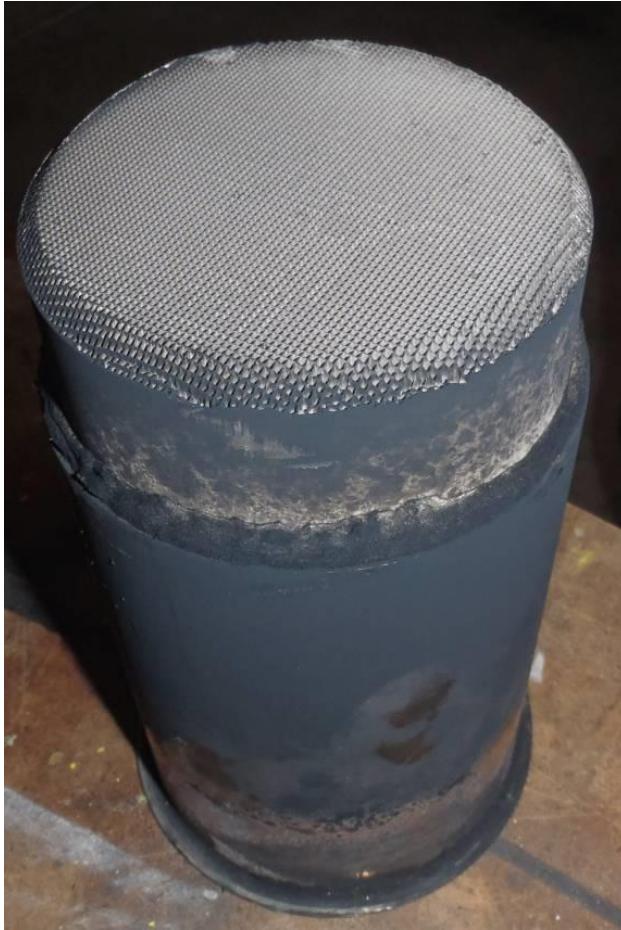
During a routine inspection at 53 hours of boat endurance testing (15% of the endurance test time), the catalyst in one of the test engines was found to have moved from its intended mounting location. The ceramic element of the catalyst was found to have partially slid out of the mantle of the catalyst. Please see the photograph in Figure 3 below for details.

Figure 3: Catalyst Mounting Failure: Ceramic Element Extending Out from the Mantle

As noted in the “Catalyst Construction” section above, the same issue was found in the original outboard marine catalyst testing project¹. When the catalysts were built for this test, the catalysts were constructed with a higher density mount mat to increase the holding pressure applied to the ceramic element based on the supplier’s recommendations.

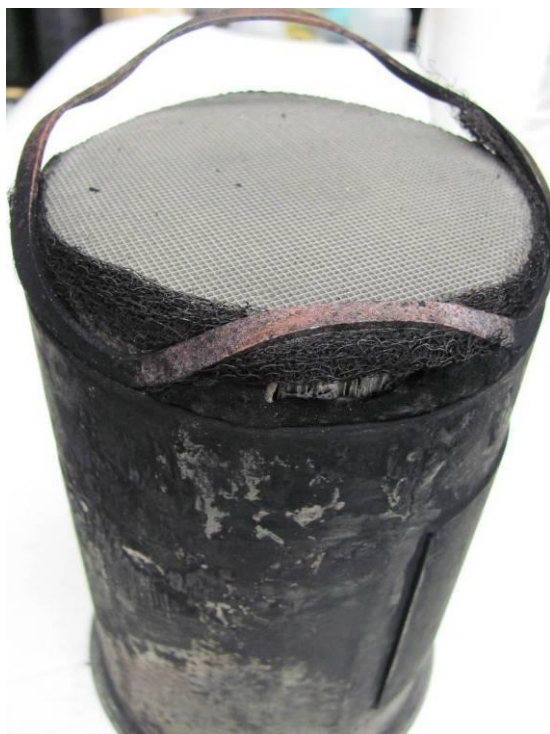
After the stop ring modifications/repairs were validated, the repaired catalysts were reinstalled in the boat endurance engines and the rest of the endurance testing was completed. Once all the endurance testing and dynamometer emissions tests were complete, the engines had the exhaust systems removed for inspection. The end of test inspection of the exhaust systems revealed the catalyst had once again slid out of the mantle. This time, however, the catalyst pushed on the stop ring, which was installed to prevent this failure mode, and broke two of the welds. The catalyst was eventually retained due to stop ring straddling the catalyst with the two remaining welds. The catalyst suffered minor damage due to hard contact with stop ring. Figure 6 shows the condition of the catalyst during the time of the final emissions testing on this engine.

Figure 6: Catalyst after Endurance with Failed Stop Ring

The failed catalyst was analyzed to determine the cause of the failure. Several issues may have contributed to the failure. These issues would include manufacturing process, mat deterioration, vibration, excessive temperature, and insufficient weld size/strength on the stop ring. In order to determine if changes made to correct all or some of the issues noted, more endurance testing would be necessary but was outside the scope of the project. Root cause was not fully identified at the time this report was written as the suppliers were still conducting additional testing as part of the investigation. Despite lack of fully understanding the root cause of the problem, there is still high confidence that an adequate solution for the catalyst mounting issue could be developed for production or a suitable replacement (metallic substrate) could be implemented. This confidence is partly based on the fact that the other engine used in the study, running under identical operating conditions (dual engine test vessel), did not show any indications of substrate movement.

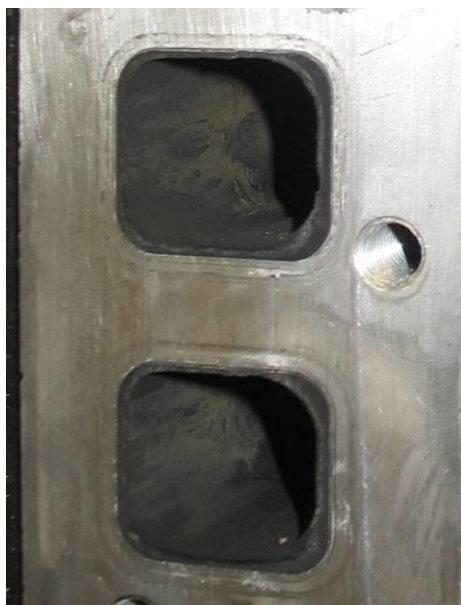
Once the boat endurance test was completed, the exhaust systems of both engines were torn down and inspected. During this inspection, the catalyst from engine 1 was found to have slid out of the mantle again despite the stop ring, as discussed in the “Problems Encountered during Testing” section above. Aside from the catalyst mounting failure, the engines and the exhaust systems appeared to be in good condition. There were no indications of water present in the exhaust system either from condensation or from reversion/splash back. See Figure 11 below.

Figure 11: Exhaust Ports from Engine 1 showing No Evidence of Water Contact

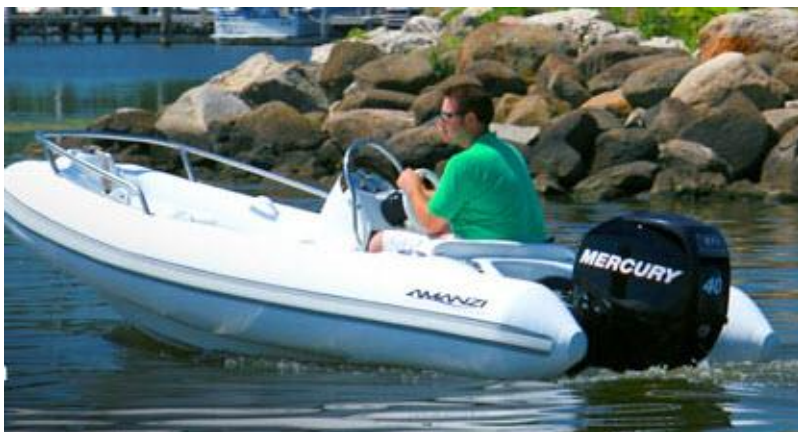
Small outboard engines inherently operate with the combustion engines near the water surface. Since the exhaust passage exits into the body of water the engine is operated in and since the cooling water mixes with the exhaust (for most outboards), water intrusion into the exhaust system needed to be considered when incorporating a catalytic converter into the exhaust system. See Figure 19 and 20 for illustration.

Figure 19: Proximity of the Engine to the Waterline

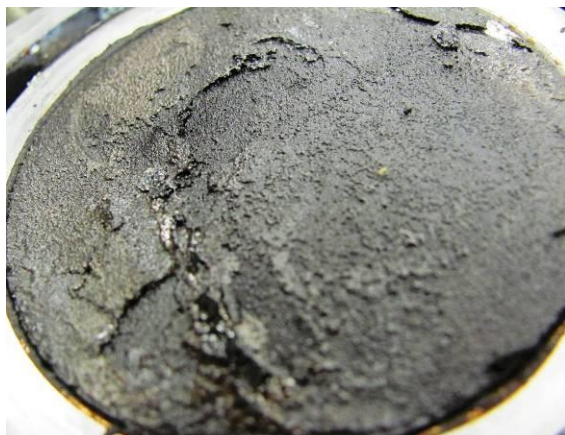
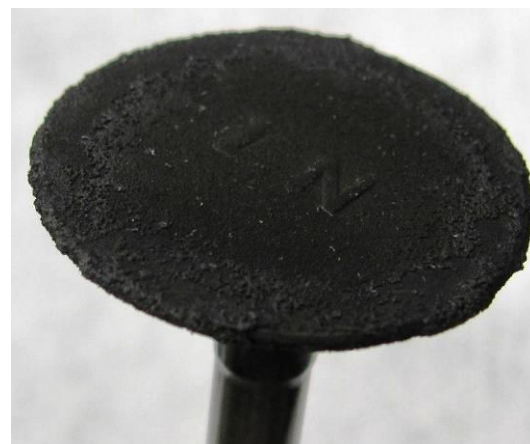
Following the post-endurance dynamometer testing, the 6HP tank endurance engine was disassembled for inspection. As mentioned above, the prototype hardware appeared to be in good condition. Significant amounts of deposits were found on the piston crown, combustion chamber, and valves, as shown in Figure 24. The deposits on the valves and combustion chamber were significant enough that they could have affected the performance loss due to restricted flow. The amount of deposit build up was not an expected result based on prior experience endurance testing the non-catalyst version of this engine family. The effects of the increased back pressure due to the catalyst and thus the amount and/or temperature of residual exhaust gas left in the chamber may have influenced the deposit build up.

Figure 24: 6HP WOT Tank Endurance Piston Crown and Intake Valve Deposits

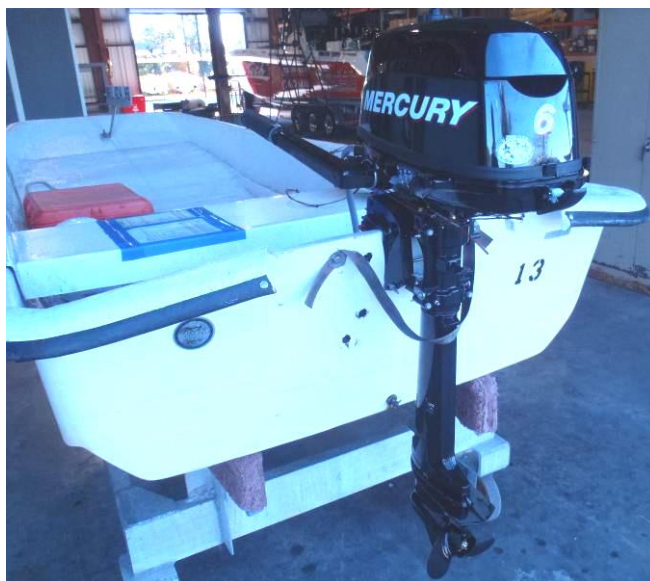
Figure 25: 6HP Boat Endurance Vessel

Once the WOT tank endurance test was completed, increasing the confidence in the durability of the prototype hardware, boat endurance testing commenced. The boat endurance vessel can be seen in Figure 25. The boat used for the test was a 14' Carolina Skiff flat bottom boat. The total boat endurance duration was 350 hours operating with a customer usage duty cycle to approximate the ICOMIA cycle. The emissions were measured at the beginning, middle, and end of the endurance test.

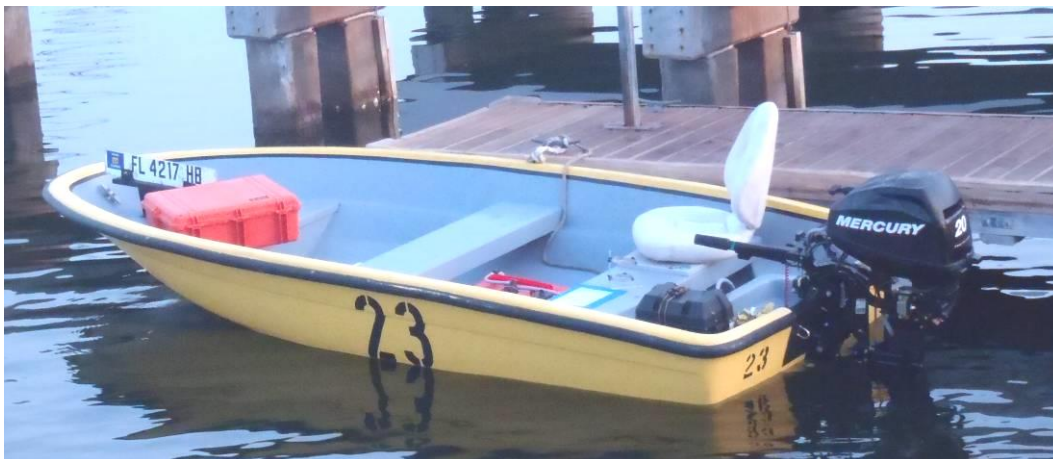
Figure 33: 20HP Boat Endurance Vessel

Since no prototype hardware issues were experienced during the WOT tank endurance test, the 20HP boat endurance engine was placed on test. A photograph of the test vessel is shown in Figure 33. The vessel used for testing was a 12' Sea Ray tender.

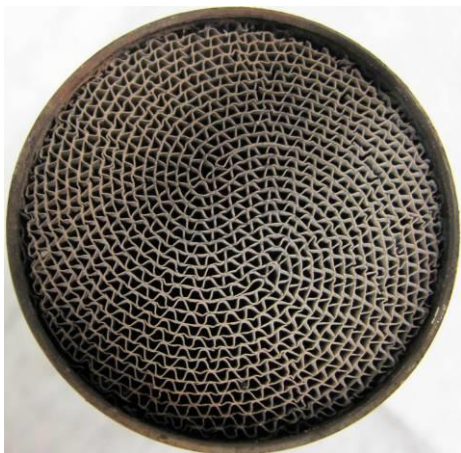
In general, the 20HP boat endurance hardware looked to be in good condition after testing. There were a few areas of the catalyst foil that showed minor flaws, likely caused by thermal conditions. A photograph of the inlet face of the catalyst is shown in Figure 38 below. None of the flaws found would be considered significant and the catalyst appeared to be in good overall condition. There were some piston crown deposits on the 20HP engine, but not nearly to the extent of the 6HP deposits. The 20HP pistons showed similar build up that appeared to be salt deposits like on the 6HP piston. The combustion chambers and valves had very little deposit build up.

Figure 38: 20HP Boat Endurance Catalyst Inlet Face – Post-Endurance

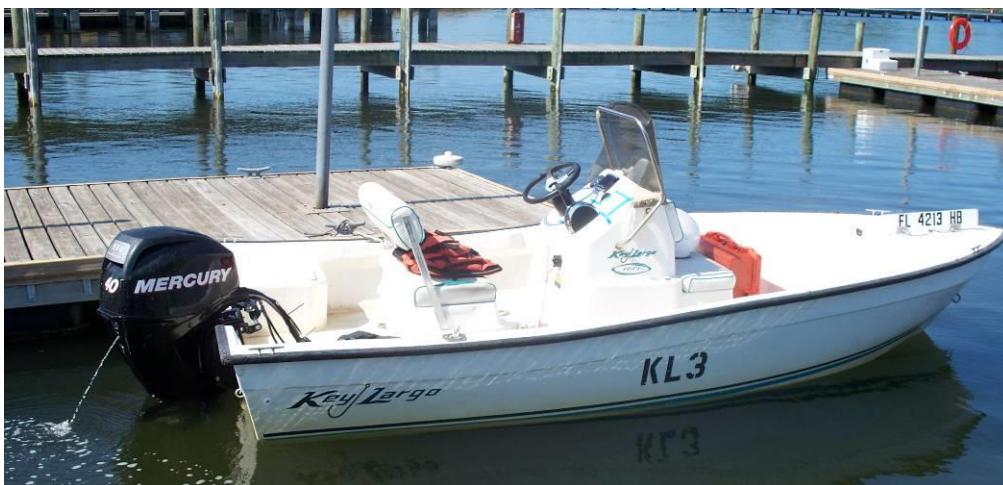
Figure 39: 40HP Boat Endurance Vessel

Once confidence was gained in the hardware during the WOT tank endurance test, the 40HP boat endurance engine was sent to the boat test facility. The engine was rigged on a 16' Key Largo center console boat shown in Figure 39 below. The 350 hour customer cycle endurance test was completed without major incident. The only recorded incident logged during testing was due to an instrumentation issue with the oil pressure data acquisition hardware.

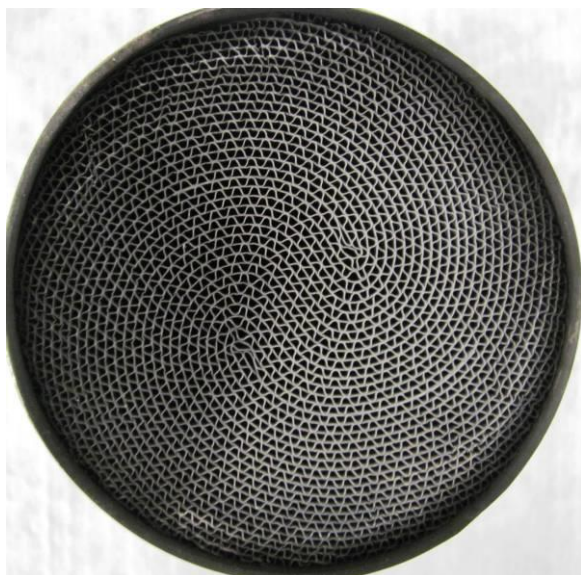
Following the boat endurance testing, the components were disassembled for inspection. Overall, the hardware appeared to be in good condition. Figure 43 shows a photograph of the inlet face of the catalyst. In general, the catalyst was in very good shape and showed no signs of excessive temperatures. There were a few areas of the catalyst matrix that showed some distortion or other evidence caused by the high temperatures normally experienced in the catalyst. In addition to inspecting the catalyst, the remainder of the exhaust system was inspected. There were some minor mineral deposits in the cooling passages, but nothing beyond what was expected. The exhaust passage downstream of the catalyst was also inspected for evidence of water intrusion, but there was no evidence of any water intrusion.

Figure 43: 40HP Boat Endurance Catalyst Inlet Face – Post-Endurance

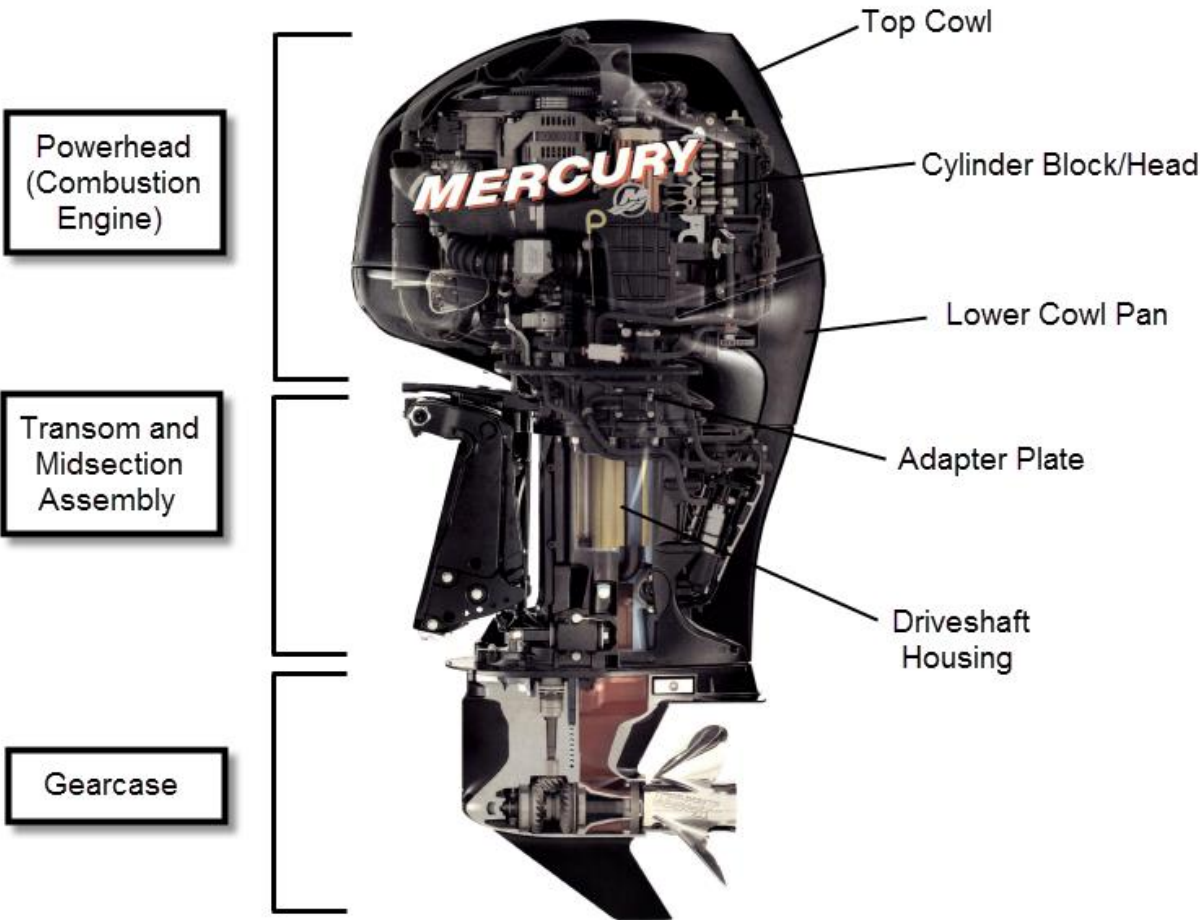
Overview of Marine Outboard Construction
